# Geotechnical Assessment of the University of Southeastern Philippines (USEP) Obrero Campus Buildings

<sup>1</sup>Engr. John Carlo O. Asis, <sup>1</sup>Engr. Merlinda Larano Lemin

<sup>1</sup>University of Southeastern Philippines, Obrero, Davao City, Philippines

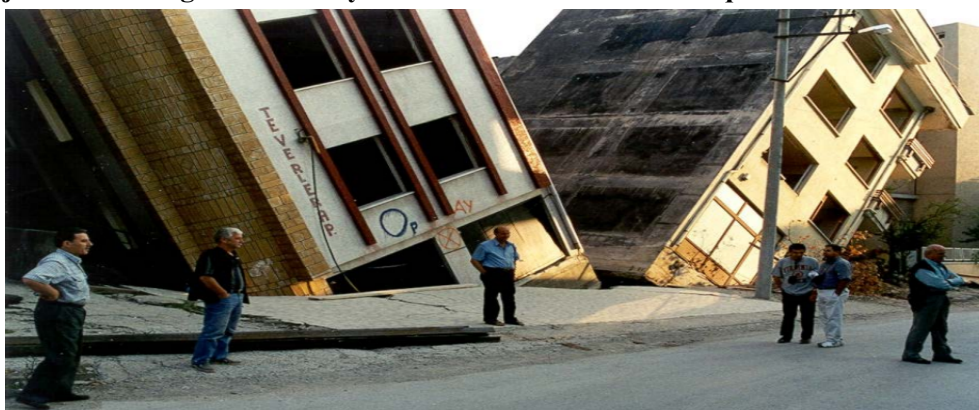
**Figure 1. 1**

**Two Adjacent Buildings Tilted Away From Each Other Due to Liquefaction in Foundation Soils**

Liquefaction is the most dangerous sort of foundation failure according to earthquake experience and can result in several catastrophic structural failures (Armouti, 2008). Ground settling refers to the post-earthquake dissipation of excess pore water pressure caused by earthquake-induced liquefaction (Federal Highway Administration, 2011). Figure 1.1 depicts a spectacular instance of liquefaction-

related structural destruction, in which two nearby structures tilted apart from one another (Hayden, 2014). In addition, the severe soil collapse depicted in Figure 1.2 occurred during the 2011 Tohoku Earthquake, the fourth most powerful quake ever recorded with a magnitude of 9.0 (Live Science, 2011).

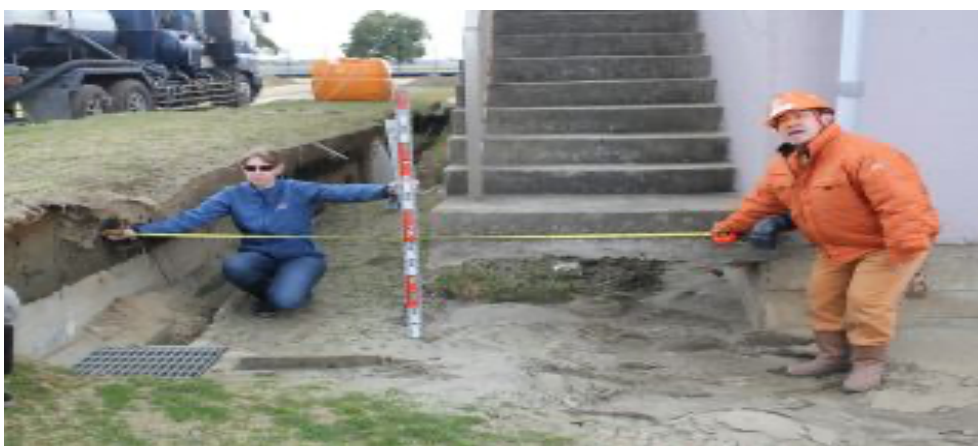
**Figure 1. 2**

**2011 Tohoku Earthquake Caused Severe Soil Collapse**
